Abattoirs as meat safety and disease surveillance points in Nigeria: The case of Ikpa slaughterhouse, Nsukka, Nigeria

I Nwankwo*, J Nwanta & J Onunkwo

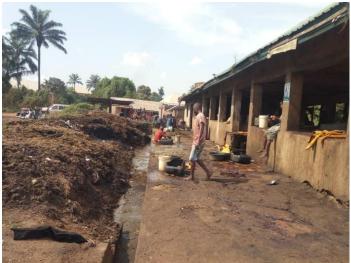
Plate I: Side view of Ikpa slaughterhouse, Nsukka. Both solid and effluent were accumulated beside the kill floor. Butchers usually slaughter on the ground floor which are already in a dilapidated condition. No adequate water supply as water is source with containers

There is an urgent need for government intervention in the provision of, portable water sources and toilet facilities at Ikpa slaughterhouse (Jayathilakan *et al.*, 2012). Improved slaughter hygiene, rapid removal of

waste from the kill floor during evisceration and washing of carcasses with potable cold water would enhance an overall reduction in meat contamination (Shafini et al., 2016). There is a need for regular fumigation of the slaughterhouse environment, treatment and disposal of slaughterhouse wastes through environmentally friendly methods like composting, landfilling and controlled incineration (Kwaghe et al., 2016). Training, wearing of protective clothing, regular health checks and fitness certificates should be made compulsory for every abattoir staff (Obidiegwu et al., 2019). The employment of more veterinarians in the service of the state government would improve regular meat inspection at the abattoirs. The use of a computer system in the compilation of the findings of a coordinated inspection and decisions made on a daily basis should be encouraged. An adequate compensation system for meat loss due to carcass condemnation would encourage cooperation and compliance with inspection outcomes.

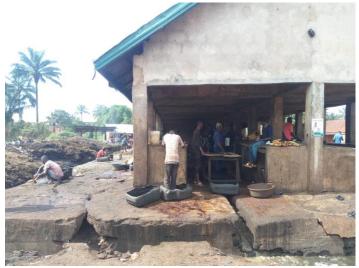
Plate II: Front view of Ikpa slaughterhouse, Nsukka showing the dilapidated condition of the kill floor and the effluent disposal channel
